National Transportation Safety Board

Performance Study

Specialist Report

Location:	New Haven, CT
Date:	August 9, 2013
Time:	1121 EDT
Airplane:	Rockwell International 690B, Registration N13622
NTSB Number:	ERA13FA358

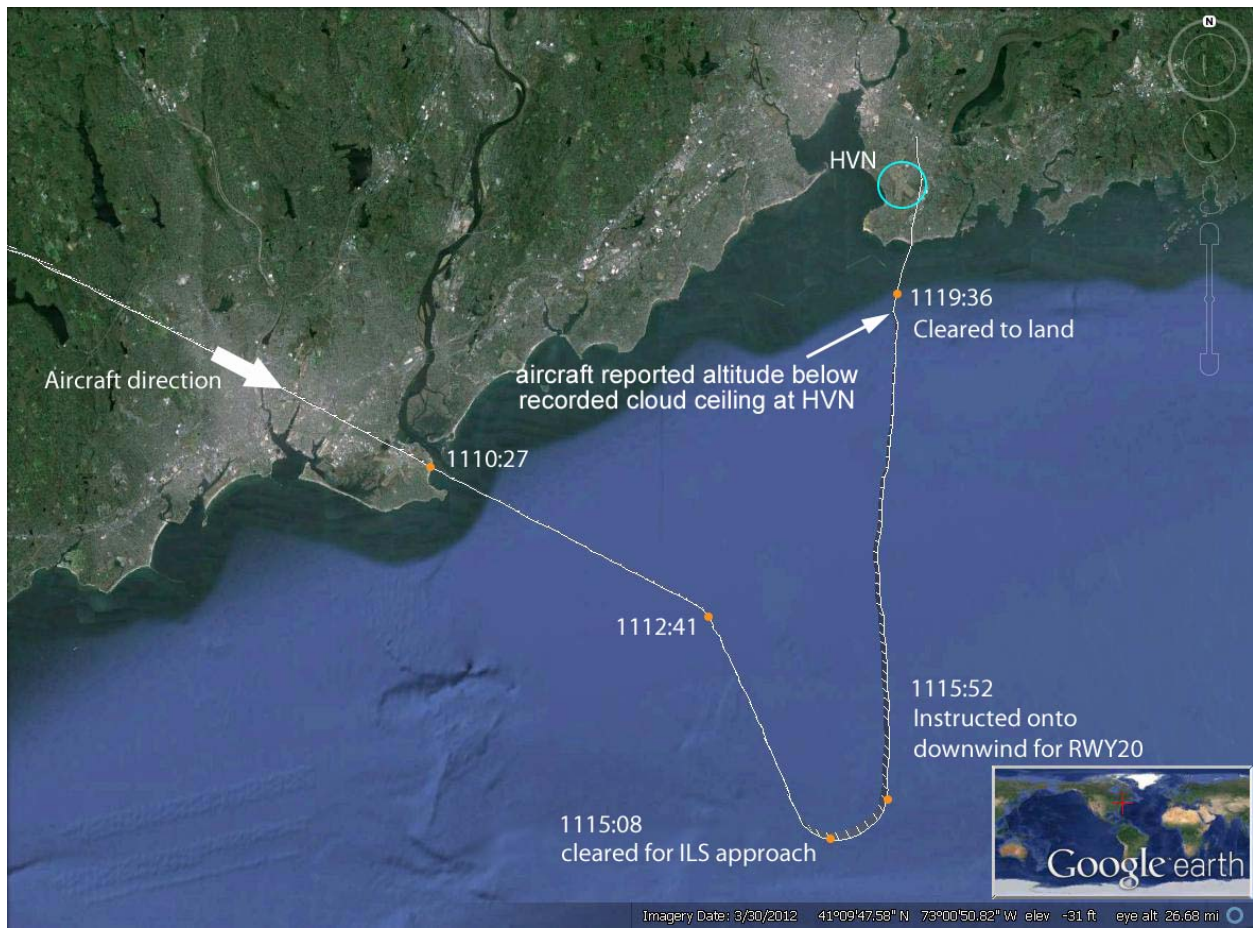
Figure 1. Aircraft radar path and ATC communications.

The flight originated from Teterboro Airport (TEB) and at 1115:08 was cleared for an ILS (instrument landing system) approach into Tweed-New Haven Airport (HVN). The radar path and ATC communications can be seen in Figure 1. The airplane turned from an earlier 155° heading to a 0° heading (see Figure 2) and was instructed onto a downwind for runway 20. Surface winds at the time of the accident would have resulted in about an 11 kts tailwind if landing on runway 2 (see Figure 3). At 1119:24 the aircraft's recorded altitude passed below the overcast ceiling reported at HVN. The aircraft's location at this time is approximately four miles and 1.5 minutes from its final radar return.

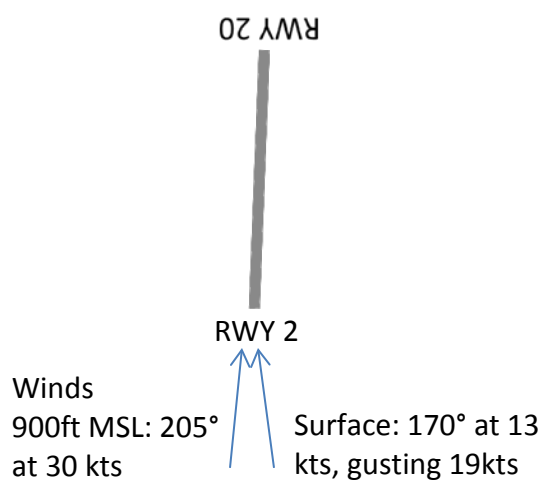
Figure 3. Winds and HVN runways.

Weather at the time of the accident was surface winds from 170° at 13 kts, gusting to 19 kts, temperature 24°C , and pressure 1012.3 hPa. At 435 ft MSL, weather was winds from 190° at 19 kts, temperature 23°C , and pressure 1000 hPa. At 900 ft MSL, the wind was from 205° at 30 kts, temperature 22°C , and pressure 984 hPa. HVN reported IFR (instrument flight rules) ceiling conditions with light rain. Visibility was 9 miles with an overcast ceiling at 900 ft agl (above ground level).

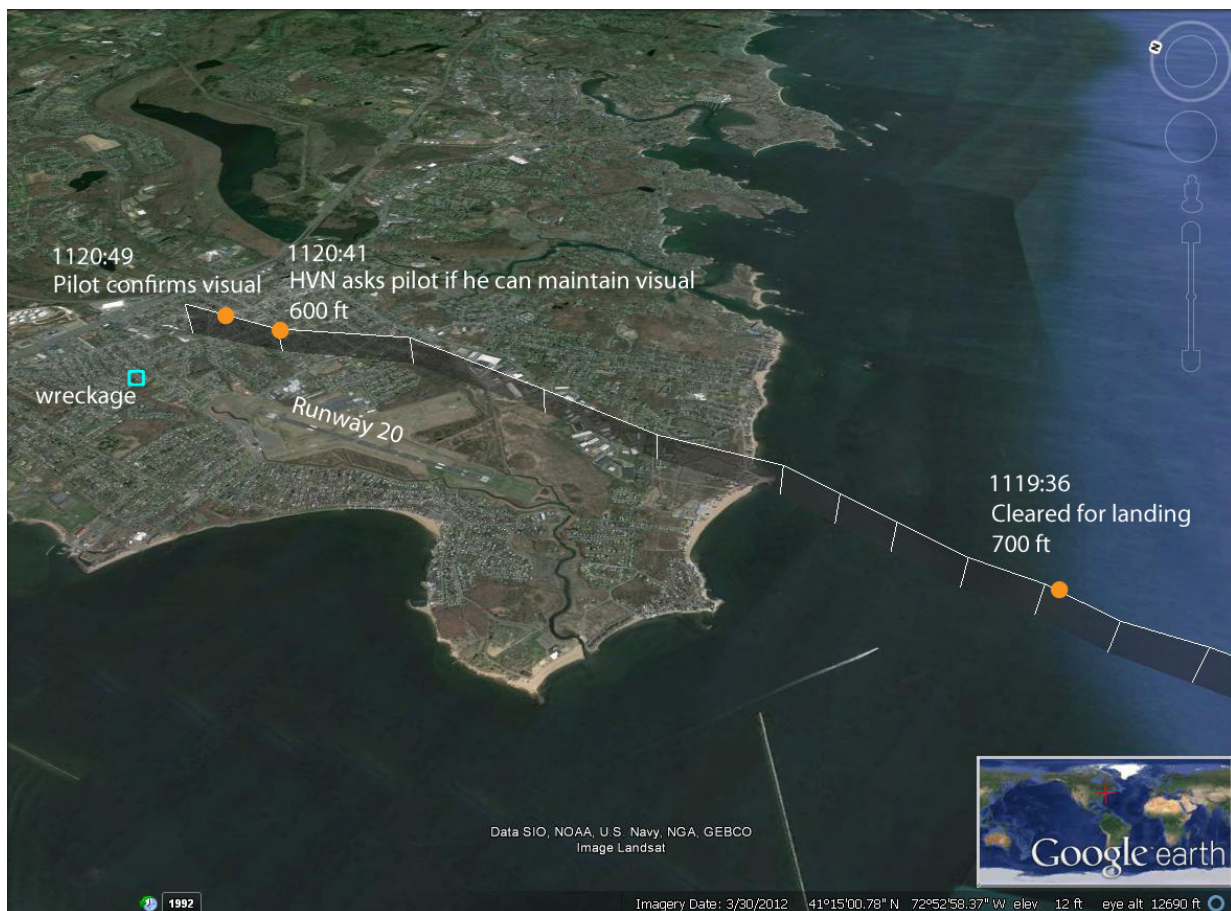
Figure 4. Aircraft radar path and ATC communications for final approach.

The aircraft was cleared for landing at 1119:32. Radar near this time records the aircraft at 700 ft mean sea level (MSL). Tweed-New Haven Airport is 12 ft above mean sea level. As shown in Figure 4, the aircraft continued along the eastern side of runway 20 and at 1120:41 was asked if he could maintain visual of the runway which the pilot confirmed. As the aircraft was on the final portion of the downwind, its ground track was between 0.4 NM (2,430 ft) and 0.48 NM (2,916 ft) away from the runway as shown in Figure 5. The last radar return was at 1120:53. Notice the last five radar returns (white vertical lines) in Figure 4 correspond with the 12 second radar and are farther apart than earlier radar returns. The airplane impacted the ground at 41°16'46.49"N / 72°53'9.51"W (blue square in Figure 4).

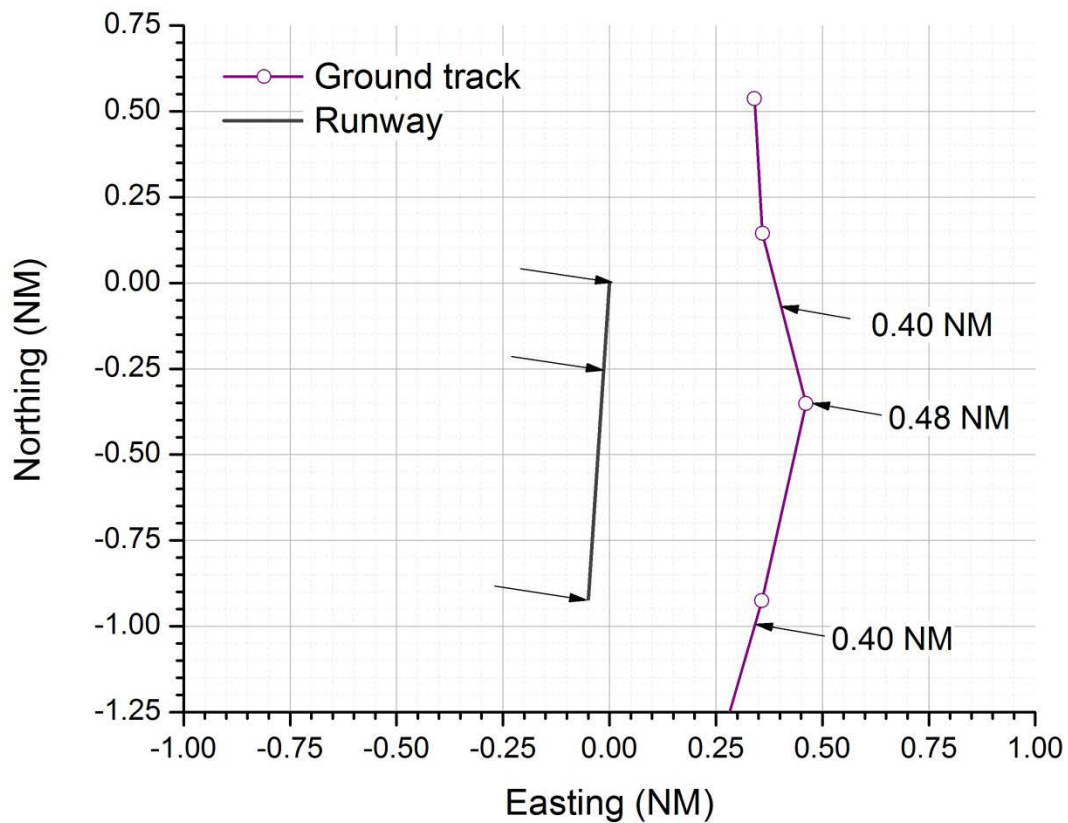
Figure 5. Aircraft ground path with relation to runway.

from about 140 kts to 100 kts and appeared to be still decreasing. The downwind portion of the flight parallel to runway 20 was between 0.4 NM and 0.48 NM from the runway center.

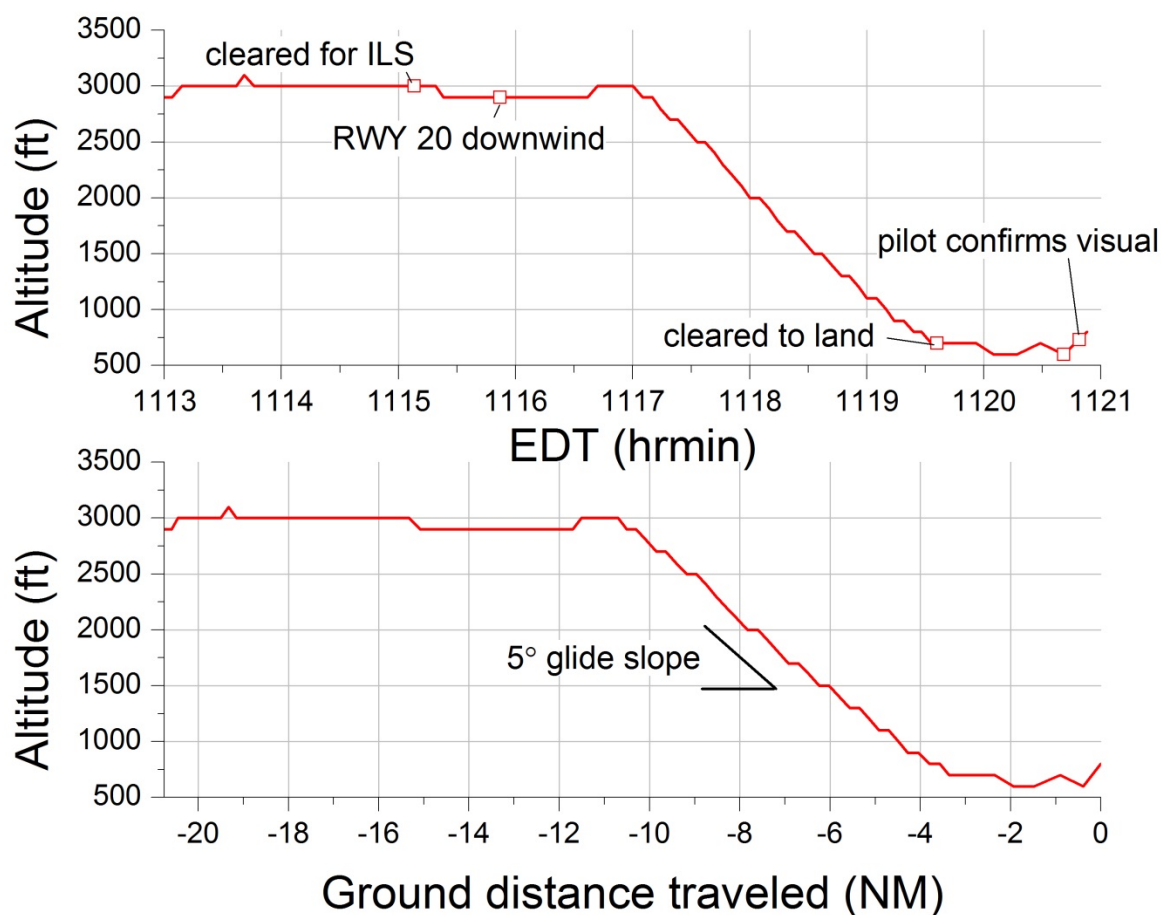
Figure 6. Aircraft altitude and glide slope.

The aircraft began descending during the downwind leg of the flight, starting at 1117 as shown in Figure 6. At about 1119:30 the aircraft leveled off between 600 and 700 ft until its last radar return at 1120:53 at 800 ft. The aircraft's glide slope from 1117 to 1119 was approximately 5°.

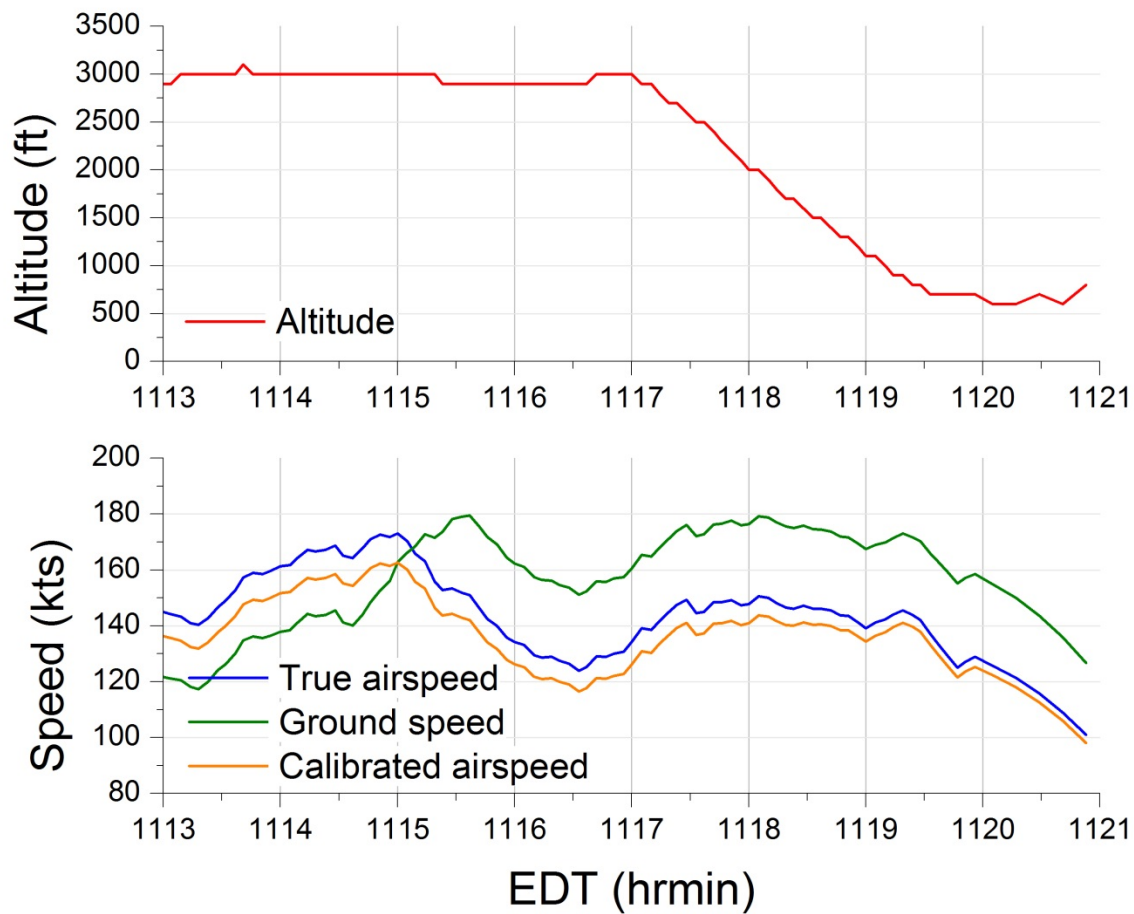
Figure 7. Aircraft altitude, calibrated airspeed, groundspeed, and true airspeed.

Groundspeed, calibrated airspeed, and true airspeed were calculated using the radar latitude and longitude and the reported winds at the time of the accident and are shown in Figure 7. Speed calculations are approximate averages of the aircraft's speed between radar data points.

During the descent from 3000 ft, the aircraft's airspeed was about 140 kts. The aircraft reduced speed as it leveled off during the final portion of the downwind and at the last radar return the estimated airspeed (both true and calibrated) was approximately 100 kts. True and calibrated airspeeds were converging as the aircraft descended to land.

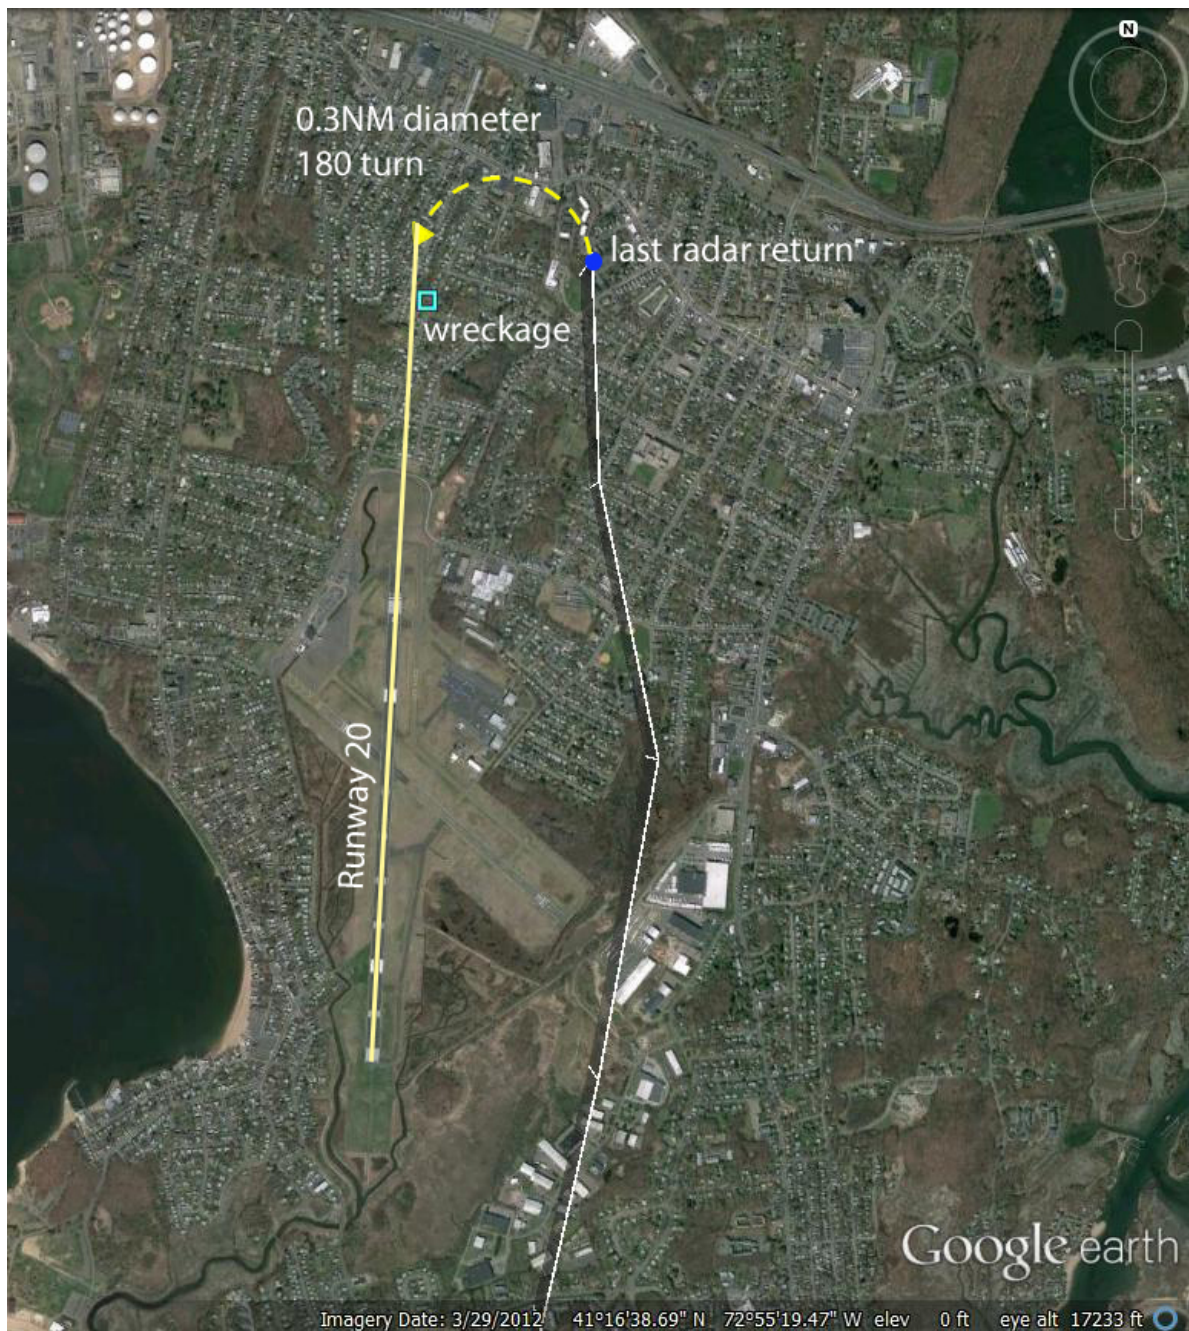
Figure 8. Possible flight path from final radar point on to heading for Runway 20.

Assuming that the pilot intended to turn from the current heading onto one in line with runway 20, the aircraft would need to make a near 180° turn with a radius of 900 ft (diameter ~ $\frac{1}{3}$ NM) as shown in Figure 8. The last airspeed approximation from the radar trajectory was 100 kts. In the equation below, θ is the bank angle necessary to complete a turn of radius R and airspeed V (g is the gravitational constant, 9.81 m/s²), assuming there are no winds.

Applying a speed of 100 kts and a radius of 900 ft, the necessary bank was calculated to be about 45° for the lift to balance the centripetal force of the turn and keep the aircraft aloft. However, this is a kinematic equation and does not guarantee that a particular aircraft would be able to generate the necessary lift at that speed. The winds from the south would tend to push the airplane to the north during the turn and the track would not be a semicircle, but that would not change the required constant bank angle calculated above. If the pilot performed a circular turn around a fixed point, he would have required a higher bank angle initially on the downwind leg, but a lower bank angle on the return upwind leg.

The aircraft's close proximity to runway 20 during the downwind leg of the approach would have required a tight turn onto final. The steep bank angle necessary for the turn combined with the aircraft's low airspeed greatly increased the likelihood of stall, which would have occurred at a speed higher than the pilot would have expected.

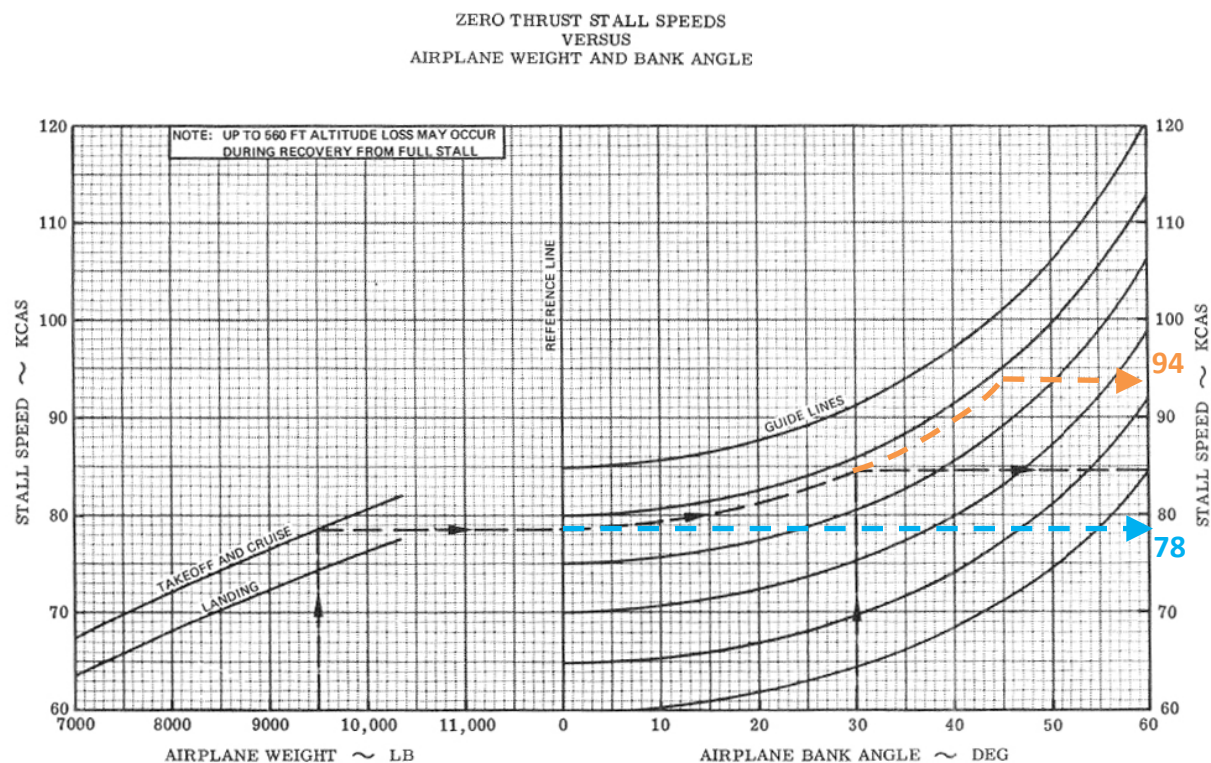
Figure 9. Airplane weight versus stall speed and bank angle versus stall speed from the Pilot's Operating Handbook for the Rockwell Commander 690B.

Figure 9 below is a plot from the Pilot's Operating Handbook for the Rockwell Commander 690B. The figure can be used to determine how increasing aircraft bank angle increases stall speeds. While the aircraft's thrust, weight, and configuration were not definitively known, the trend can be determined. A 9,500 lbs aircraft at cruise would stall at 78 kts wings level (blue line in Figure 9), but at 84.5 kts in a 30° bank (the dotted line example in Figure 9). Extrapolating to a 45° bank (orange line Figure 9), the stall speed increases to 94 kts. For a 9,500 lbs aircraft in the landing configuration (full flaps 40°), the stall speed at 45° bank is 88 kts. Using the plot to determine the increase in stall speeds for a variety of configurations reveals that a 45° bank will increase the stall speed by about 20% compared to the level flight speed. Additionally, the model does not account for uncoordinated flight, such as if the aircraft was slipping or cross-controlled during the turn from the downwind onto final. If the aircraft was in uncoordinated flight, its angle of attack would most probably be greater on one of the wings, further decreasing the stall speed.
